Contract #: 04-0120F4Cty: SF/ALA Rte: 80 PM: 13.2/13.9File #: 99.28**WELDING INSPECTION REPORT****Resident Engineer:**Siegenthaler, Peter**Address:** 333 Burma Road**City:** Oakland, CA 94607**Report No:** WIR-022499**Date Inspected:** 14-Apr-2011**Project Name:** SAS Superstructure**OSM Arrival Time:** 800**Prime Contractor:** American Bridge/Fluor Enterprises, a JV**OSM Departure Time:** 1630**Contractor:** Watson Bowman Acme Corporation**Location:** Buffalo, NY**CWI Name:** Gregory Ross**CWI Present:** Yes No**Inspected CWI report:** Yes No N/A**Rod Oven in Use:** Yes No N/A**Electrode to specification:** Yes No N/A**Weld Procedures Followed:** Yes No N/A**Qualified Welders:** Yes No N/A**Verified Joint Fit-up:** Yes No N/A**Approved Drawings:** Yes No N/A**Approved WPS:** Yes No N/A**Delayed / Cancelled:** Yes No N/A**Bridge No:** 34-0006**Component:** Seismic Joint A Mock-up**Summary of Items Observed:**

WELDING INSPECTION REPORT

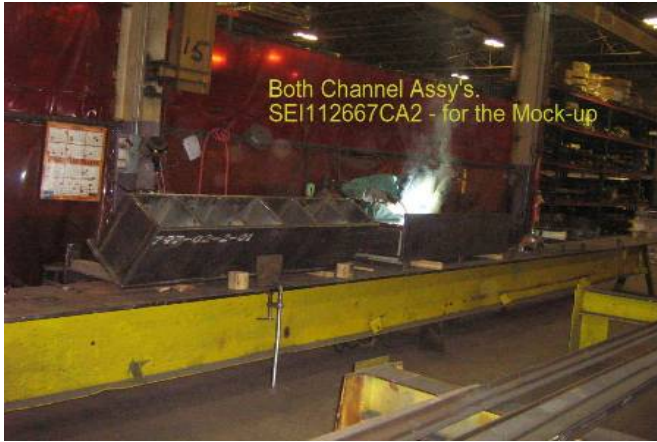
This QA inspector observed certified welder Jayson Gray using the FCAW process to weld Complete Joint Penetration (CJP) welds on the SEI112667CA2 Channel Assemblies for the mock-up. The approved FCAW Welding Procedure Specification (WPS) was Watson Bowman - WPS FCAW 13. All welding was being performed in the 1G flat position.
